Callaway Turbine Trip - Failure of Isolated Phase Bus System

BY BRUCE HACK, MANAGING MEMBER, CROWN ELECTRIC ENGINEERING & MANUFACTURING AND MARK D. HAAG, PRINCIPAL DESIGN ENGINEER, NUCLEAR SERVICES, AMEREN MISSOURI

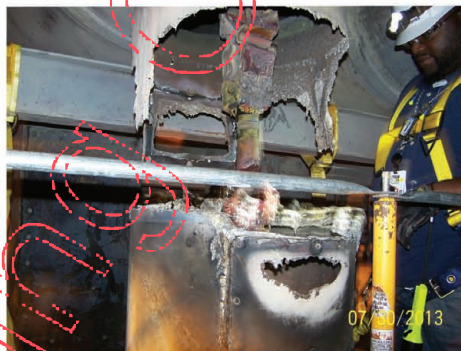
A WORKER INSPECTS THE FAULTED ISOLATED PHASE BUS. PHOTOS COURTESY AMEREN MISSOURI.
