Callaway Turbine Trip - Failure of Isolated Phase Bus System

BY BRUCE HACK, MANAGING MEMBER, CROWN ELECTRIC ENGINEERING & MANUFACTURING AND MARK D. HAAG, PRINCIPAL DESIGN ENGINEER, NUCLEAR SERVICES, AMEREN MISSOURI

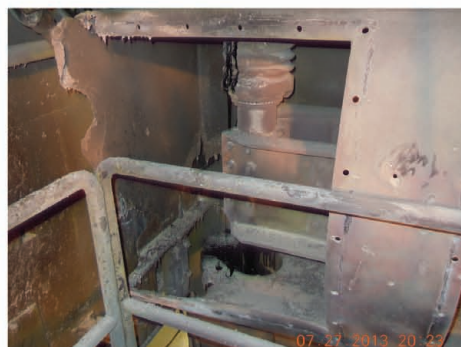
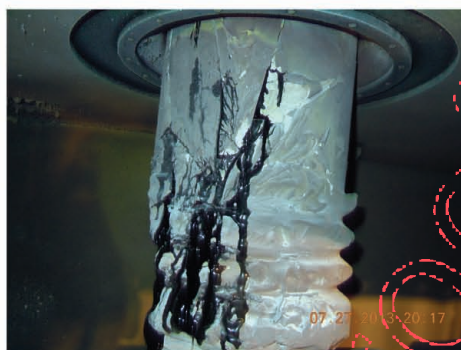
A WORKER INSPECTS THE FAULTED ISOLATED PHASE BUS. PHOTOS COURTESY AMEREN MISSOURI.

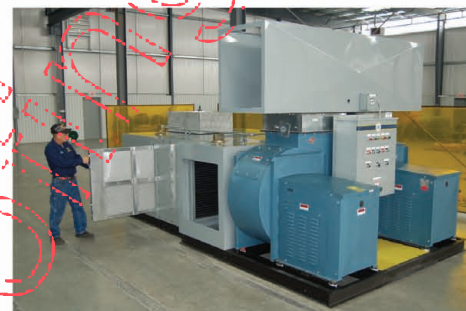
Callaway's cooling skid heat exchanger assemblies employ so-called "back-draft" dampers located on the fan discharge. One of the back-draft damper blades had broken free and entered the "B" phase of the iso phase bus duct. As the blade flew through the IPB's "B" phase, it caused repeated short lived phase-to-ground electrical faults. Ultimately, the condition cascaded into a massive electrical fault of 180,000 amps rms at both the IPB seal off bushing for the auxiliary transformer's "B" phase tap as well as at the main generator neutral connection box. This final massive short circuit led to a turbine/generator and reactor trip.

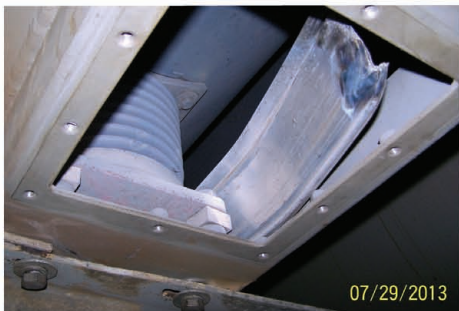
The damper blade breaking free was problematic enough, but a single fault to ground should not initiate such a response in iso phase bus. What happened?

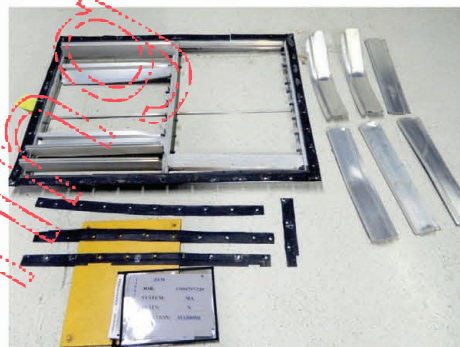
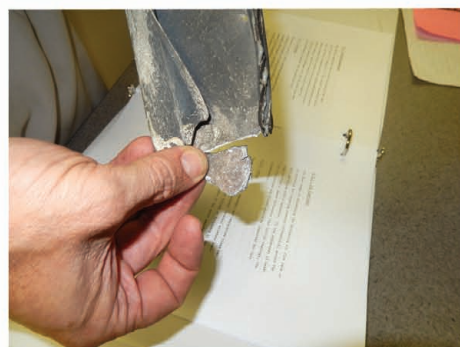
Since the plant's original construction, the air flow rates from the iso-phase cooling fans were higher than the design ratings of the iso-phase cooler backdraft dampers. The elevated flow rates through the backdraft dampers increased the risk of damper failure. Callaway Engineering believes backdraft dampers should have a more robust design for this intended application. One example of the

damper's weak link was that plastic retaining clips served as bushings to allow operation of the damper blades.

Back in January 2005, flow rates were estimated to be as high as 40,000 cfm. Air flow measurements were taken in May 2007 and found to be 34,000 cfm. More accurate data on the specifics of the system's operation would have likely pointed to the need for corrective actions to be taken in a more timely fashion.

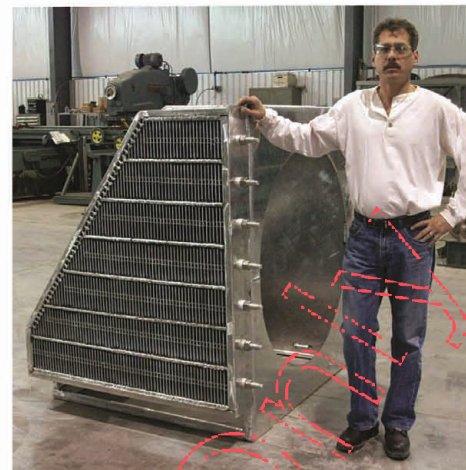
The air flow change caused during the monthly swapping of the fans carried the thrown damper blade into a position that caused arcing in the "B" phase of the IPB. The flying damper blade is suspected of intermittently causing short duration arcing, pitting and damage as it was blown around the iso phase duct during a 14-minute operational period. Arcing, pitting and associated damage was found periodically through a 40-foot section of the iso phase bus work. An oscillography from the 311/G generator protection relay captured one neutral voltage spike of 13.1 kV. This fault then clears itself as evidenced by the VN voltage dropping back to zero. The last momentary arc was caught in the pre-fault data initiated by the protection relay lockout. Neutral bus currents during these initial faults were limited to 12.8 Amps through the neutral grounding transformer.

The dislodged damper blade that flew and arced along the IPB vaporized along its trajectory. Clouds of ionized gas and metal vapor - think comet tails - are winging through the IPB system, completing a round trip every 13.5 seconds. Over time this metal vapor cloud, in part, collects on the cool porcelain surfaces of both the "B" phase iso-phase seal off bushing for the unit-auxiliary transformer and at the main generator neutral connection box. These locations present cooler surfaces and are both points in the air stream system which are deadened zones not seeing full forced air flow. It is noted that there are no de-ionizers in the flow path between the arcing location and the unit auxiliary transformer connection location. Further, the neutral connection box under the generator had com-

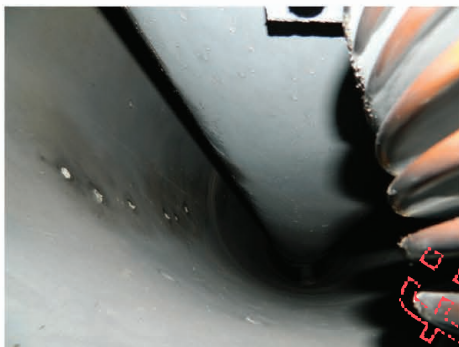
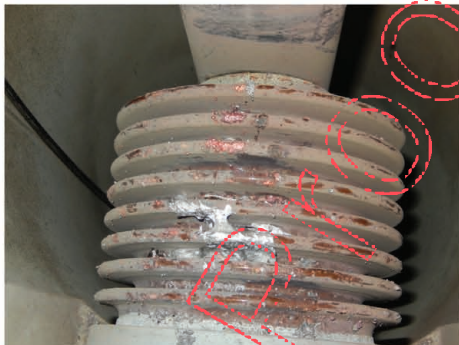
Oscillography offers verification of the iso phase bus phase-B intermittently going to ground. This was most likely due to the continued movement of the arcing damper blade resulting in additional gas cloud generation and potentially resulting in blowing an arc down the ductwork.

At some point, the damper blade lodged in the F-tap pocket of the seal-off bushing for the "B" phase IPB connection to the unit auxiliary transformer. The damper blade is now easily jumping out the bushings line to ground integrity. The compromised main generator neutral (in the neutral connection box) and the unit auxiliary T-tap are both co-faulting directly to ground. This ground loop completely bypasses the generator neutral resistor connection resulting in a solid line to ground fault on the generator 220 kA.

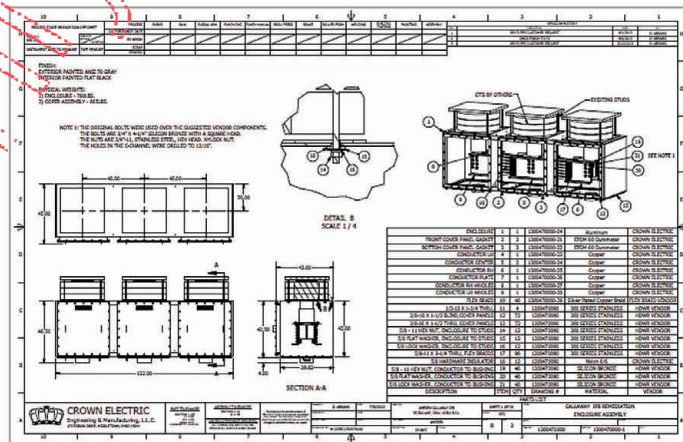
Each bus was thoroughly inspected and all identified foreign material was removed. The

iso phase bus with all its support insulators was completely cleaned. Filters were replaced; bus insulators, bushings, dampers, and deionizers were provided and replaced as necessary. New backdraft dampers with modified catch screens were installed. Flow testing in the system was performed. The seal-off bushings were cleaned or replaced and tested. The iso phase bus was then Hi-Pot tested.
